Re: Notice of Violation  
Compliance Evaluation Inspection  
WID006072979

RCRA COMPLIANCE EVALUATION INSPECTION REPORT

**SITE NAME:** Baker Manufacturing Company, LLC

**DATE OF INSPECTION:** February 27, 2015

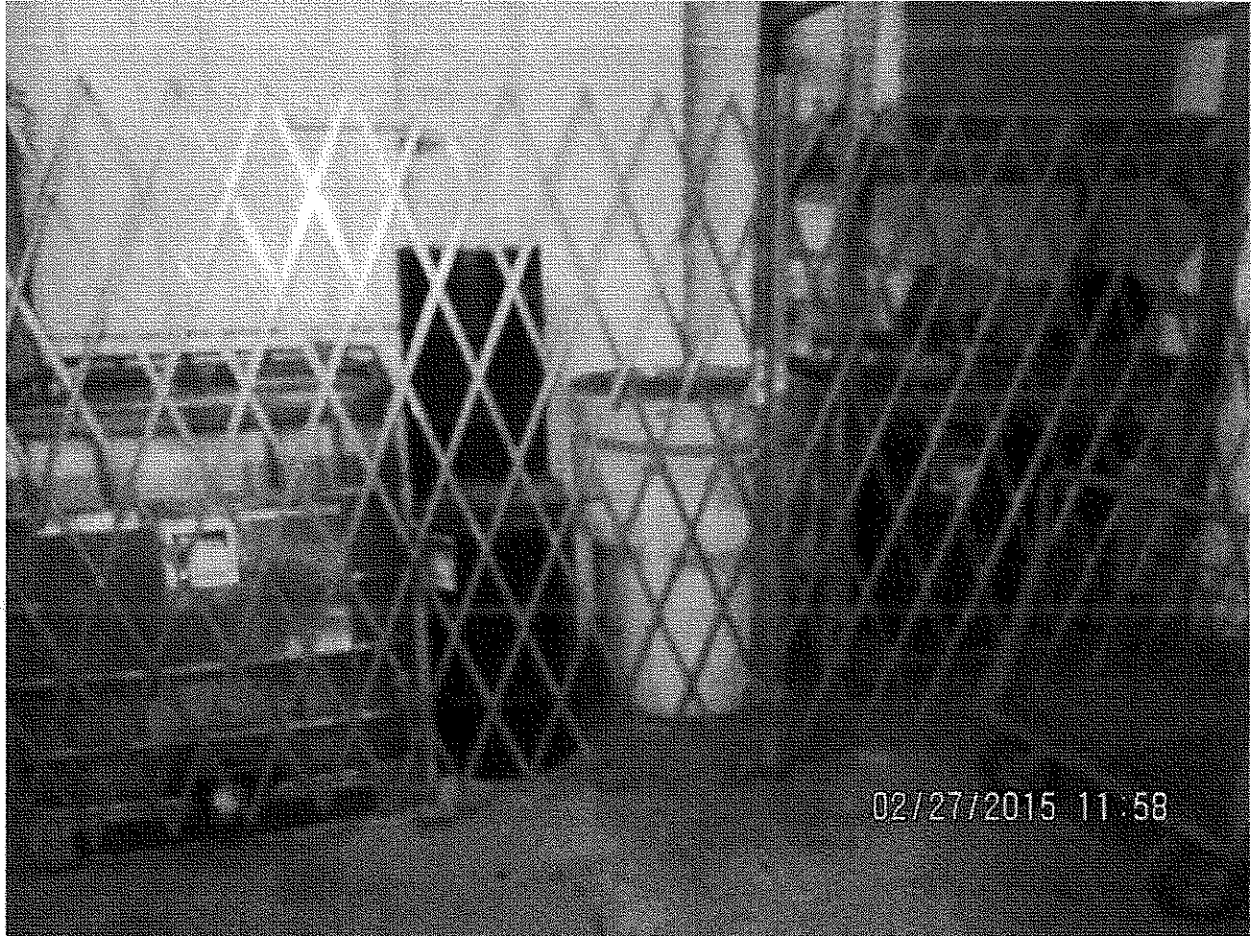
**Photograph Number: 1**

**Photograph Description: Caged used oil collection area in Bldg. #20.**

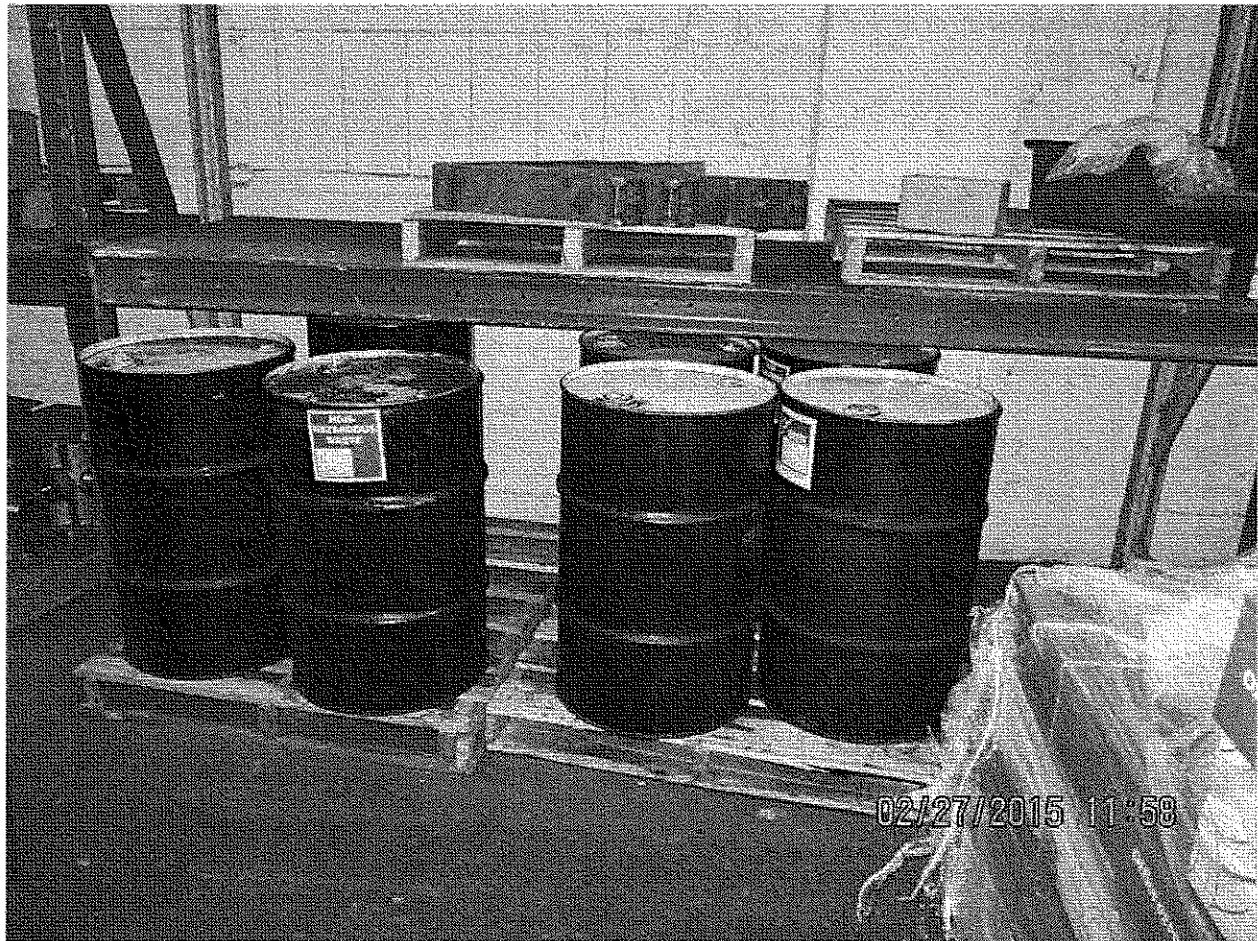
**Photograph Number:** 2

At the time of the inspection, one 300-gallon tote and eight 55-gallon containers of used oil, located in Baker's Bldg. # 20 used oil storage area, and 300-gallon tote of used coolant in Bldg. #5, were not labeled with the words, "Used Oil."

**Photograph Description:** Drums of used oil next to the caged used oil collection area Bldg. #20.

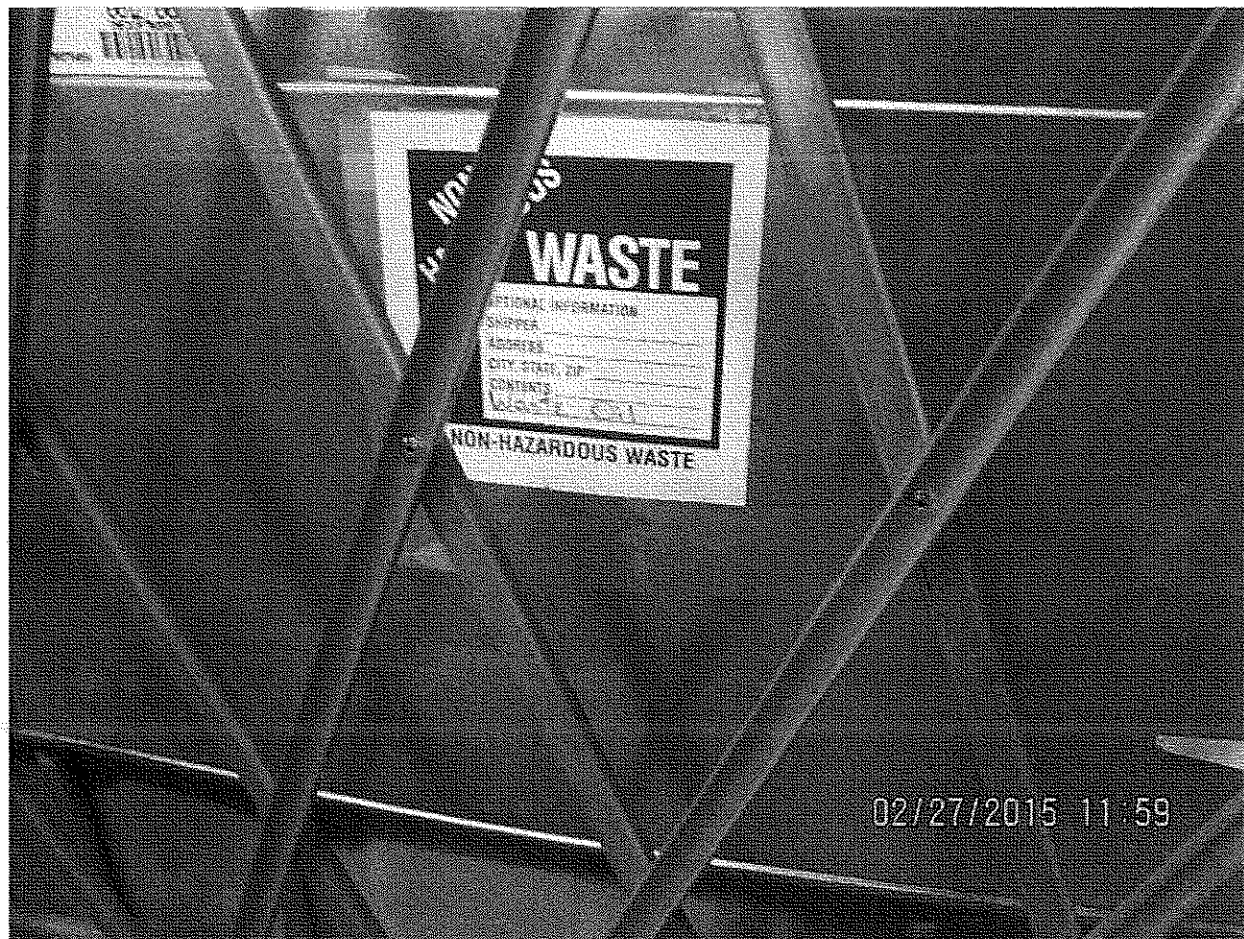
**Photograph Number:** 3

**Photograph Description:** Sample of labeling found on Barker's used oil containers stored in the facility's used oil collection area ("Waste Oil.")

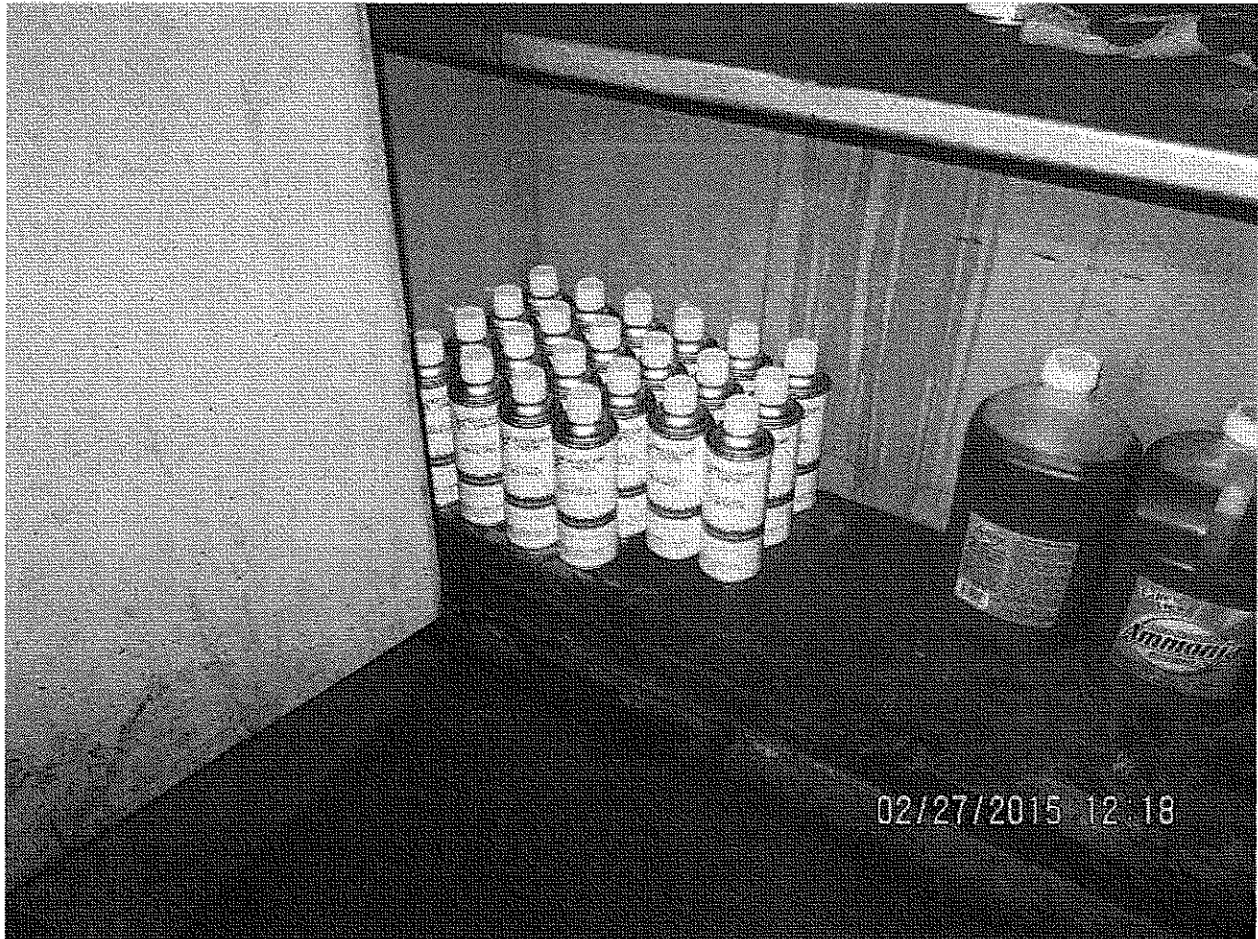
**Photograph Number:** 4

**Photograph Description:** Contents of the fire proof locker located in Bldg. # 12 dip paint operation.

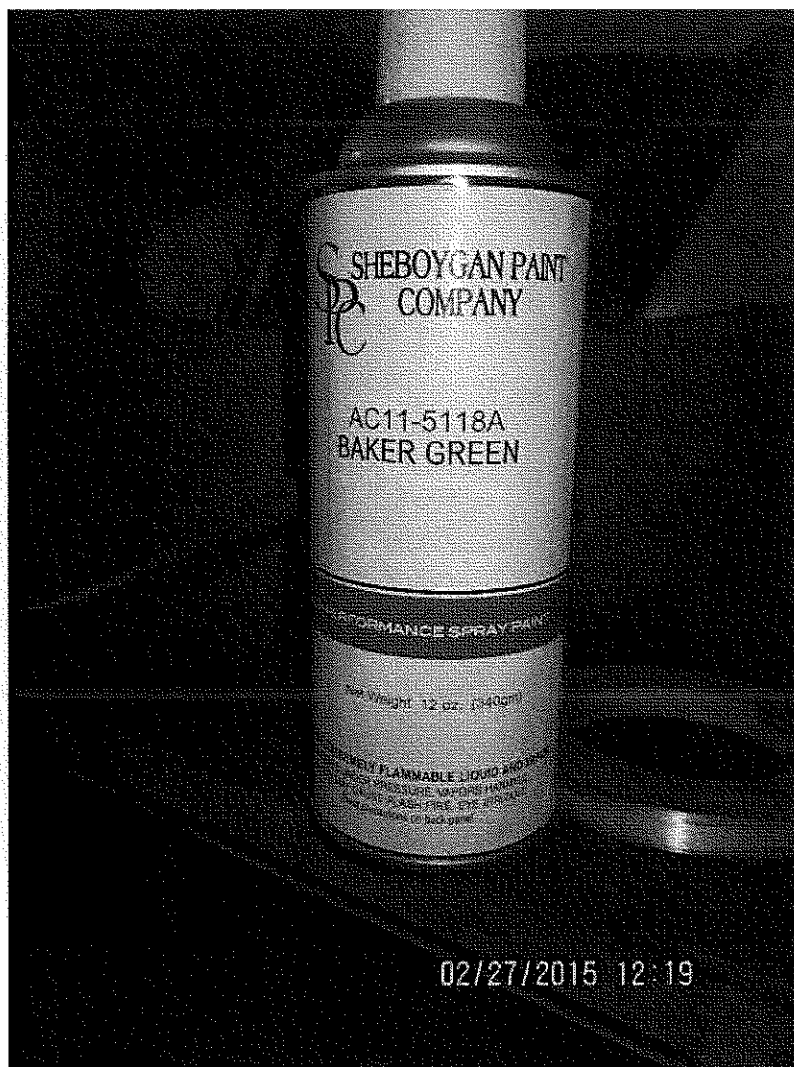
**Photograph Number:** 5

**Photograph Description:** Close-up of the label of the aerosol product found in the fire proof locker in Bldg. #12.

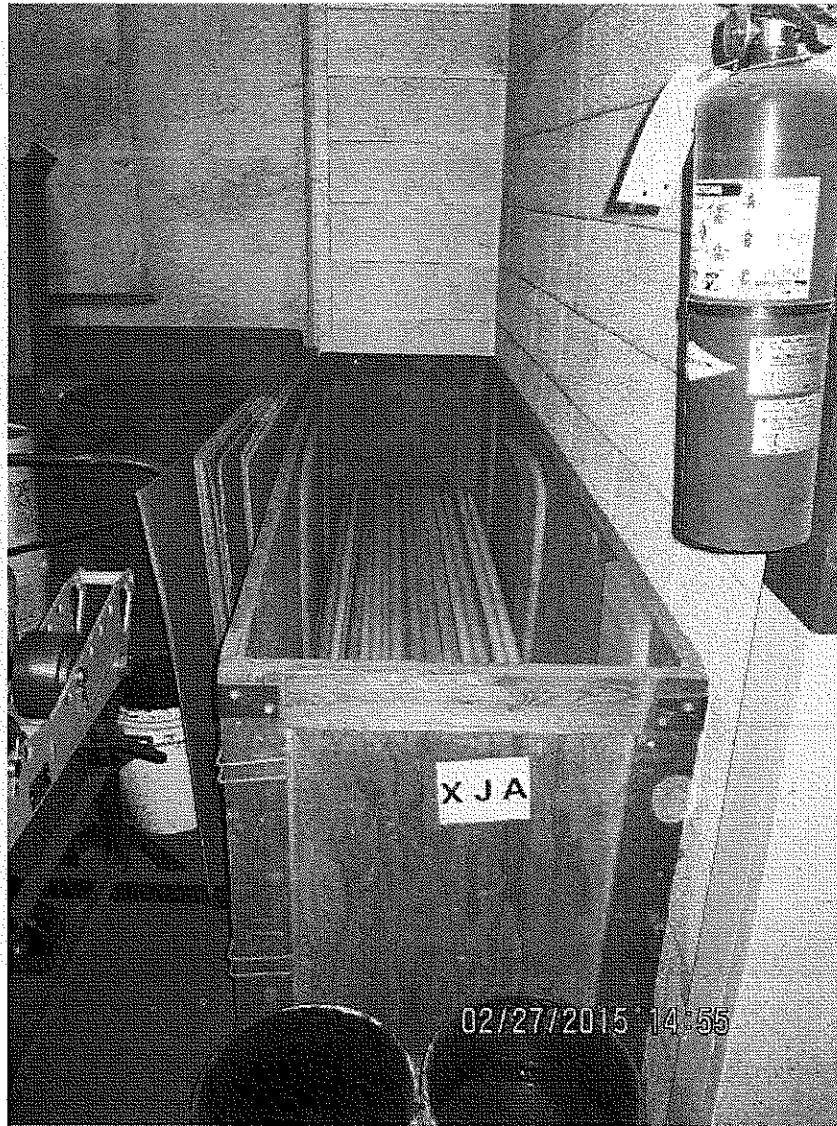
**Photograph Number:** 7

At the time of the inspection, Baker's container of four foot lamps was not labeled with the phrase "Universal Waste-Lamps," "Waste Lamps" or "Used Lamps."

At the time of the inspection, Baker's containers accumulating four foot and eight foot lamps was not closed.

**Photograph Description:** Close-up of the unlabeled and open 8ft box of Baker's used fluorescent lamps.

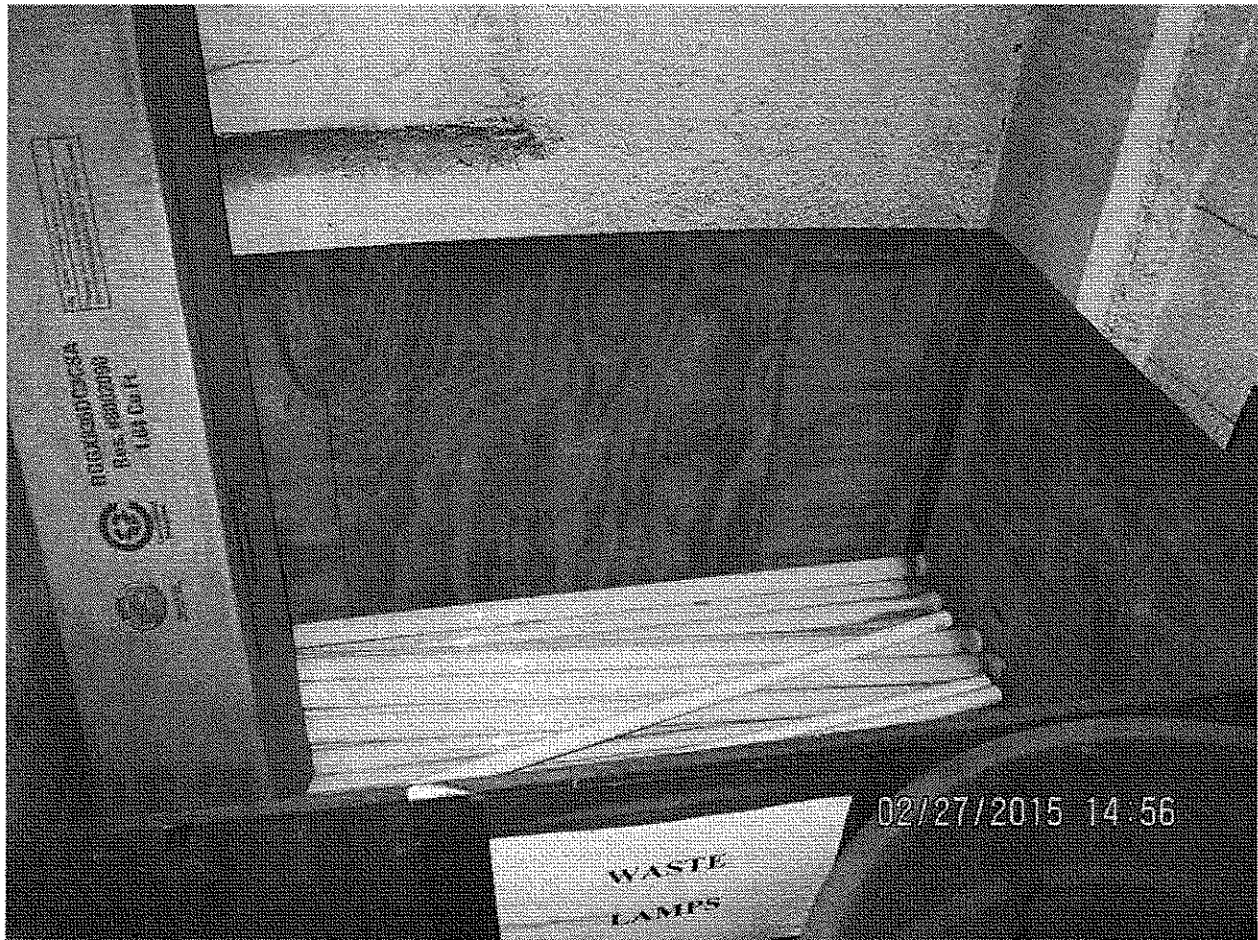
**Photograph Number:** 8

**Photograph Description:** Close-up of the open 4ft box of Baker's used fluorescent lamps showing labeling of the container.

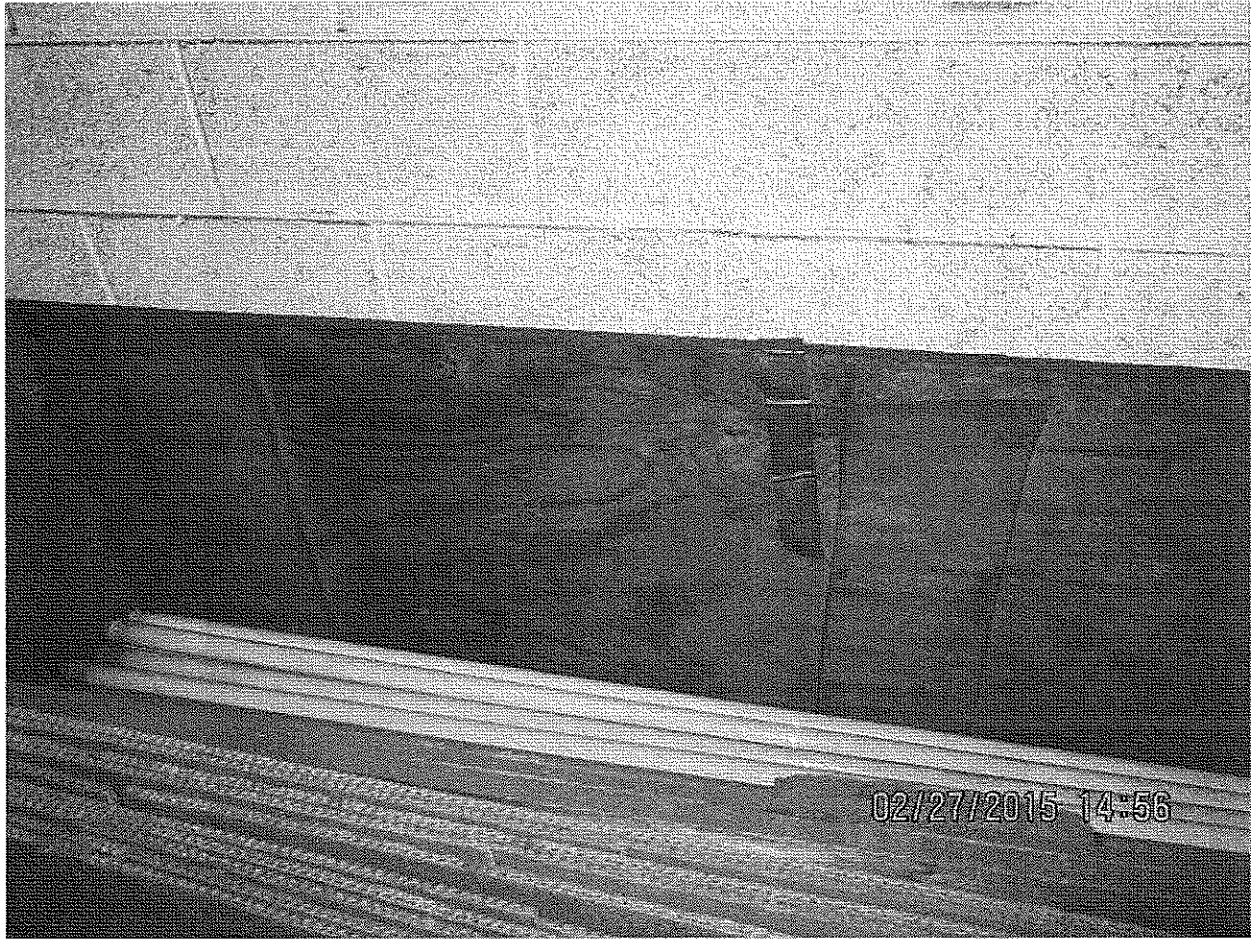
**Photograph Number:** 9

**Photograph Description:** Additional view of the 8ft box storing used fluorescent lamps pictured in photo #7.

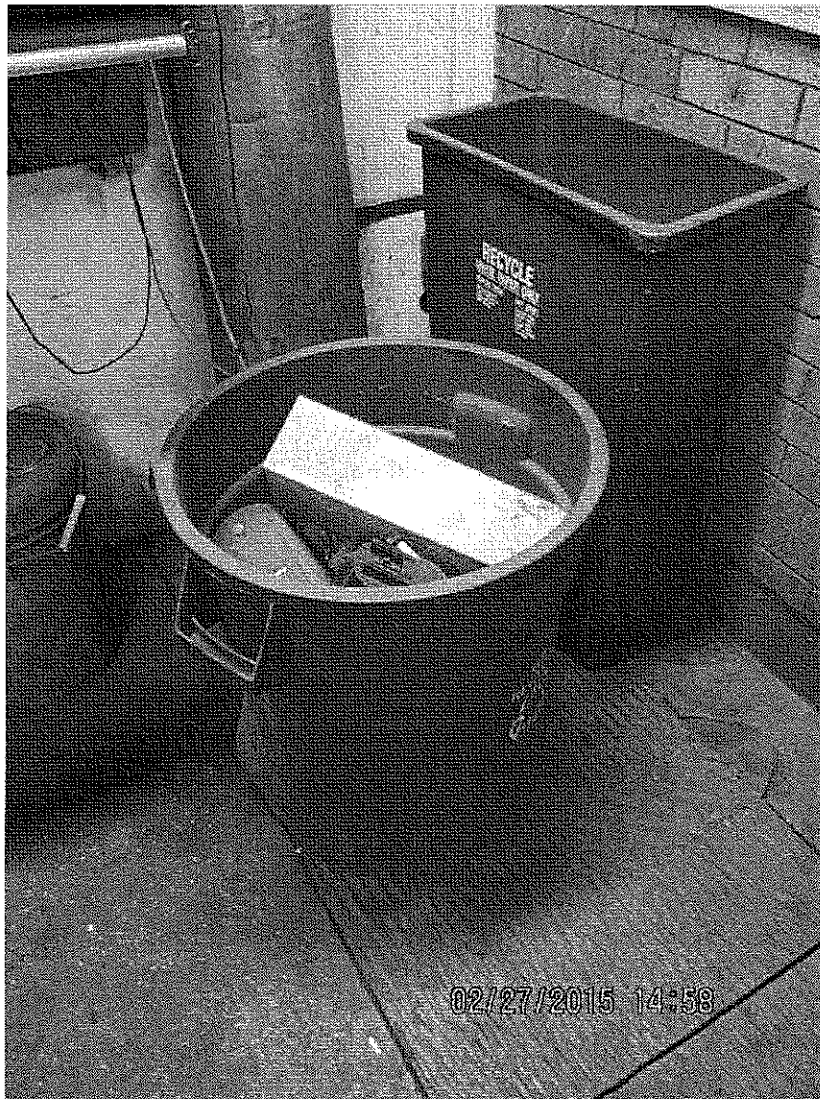
**Photograph Number:** 10

At the time of the inspection, Baker's container of used batteries located in Bldg. #5 was not labeled with the phrase "Universal Waste-Batteries," "Waste Batteries" or "Used Batteries."

**Photograph Description:** Unlabeled container of used batteries in Baker's universal waste storage area.
